MARGERIE LAKE RESERVOIR DAM  
CT 00063

PHASE I INSPECTION REPORT  
NATIONAL DAM INSPECTION PROGRAM

DECEMBER 1978

Identification No. CT 00063  
Name of Dam: Margerie Lake Reservoir Dam  
Town: Danbury  
County and State: Fairfield County, Connecticut  
Stream: Tributary of Padanaram Brook  
Date of Inspection: 23 October 1978

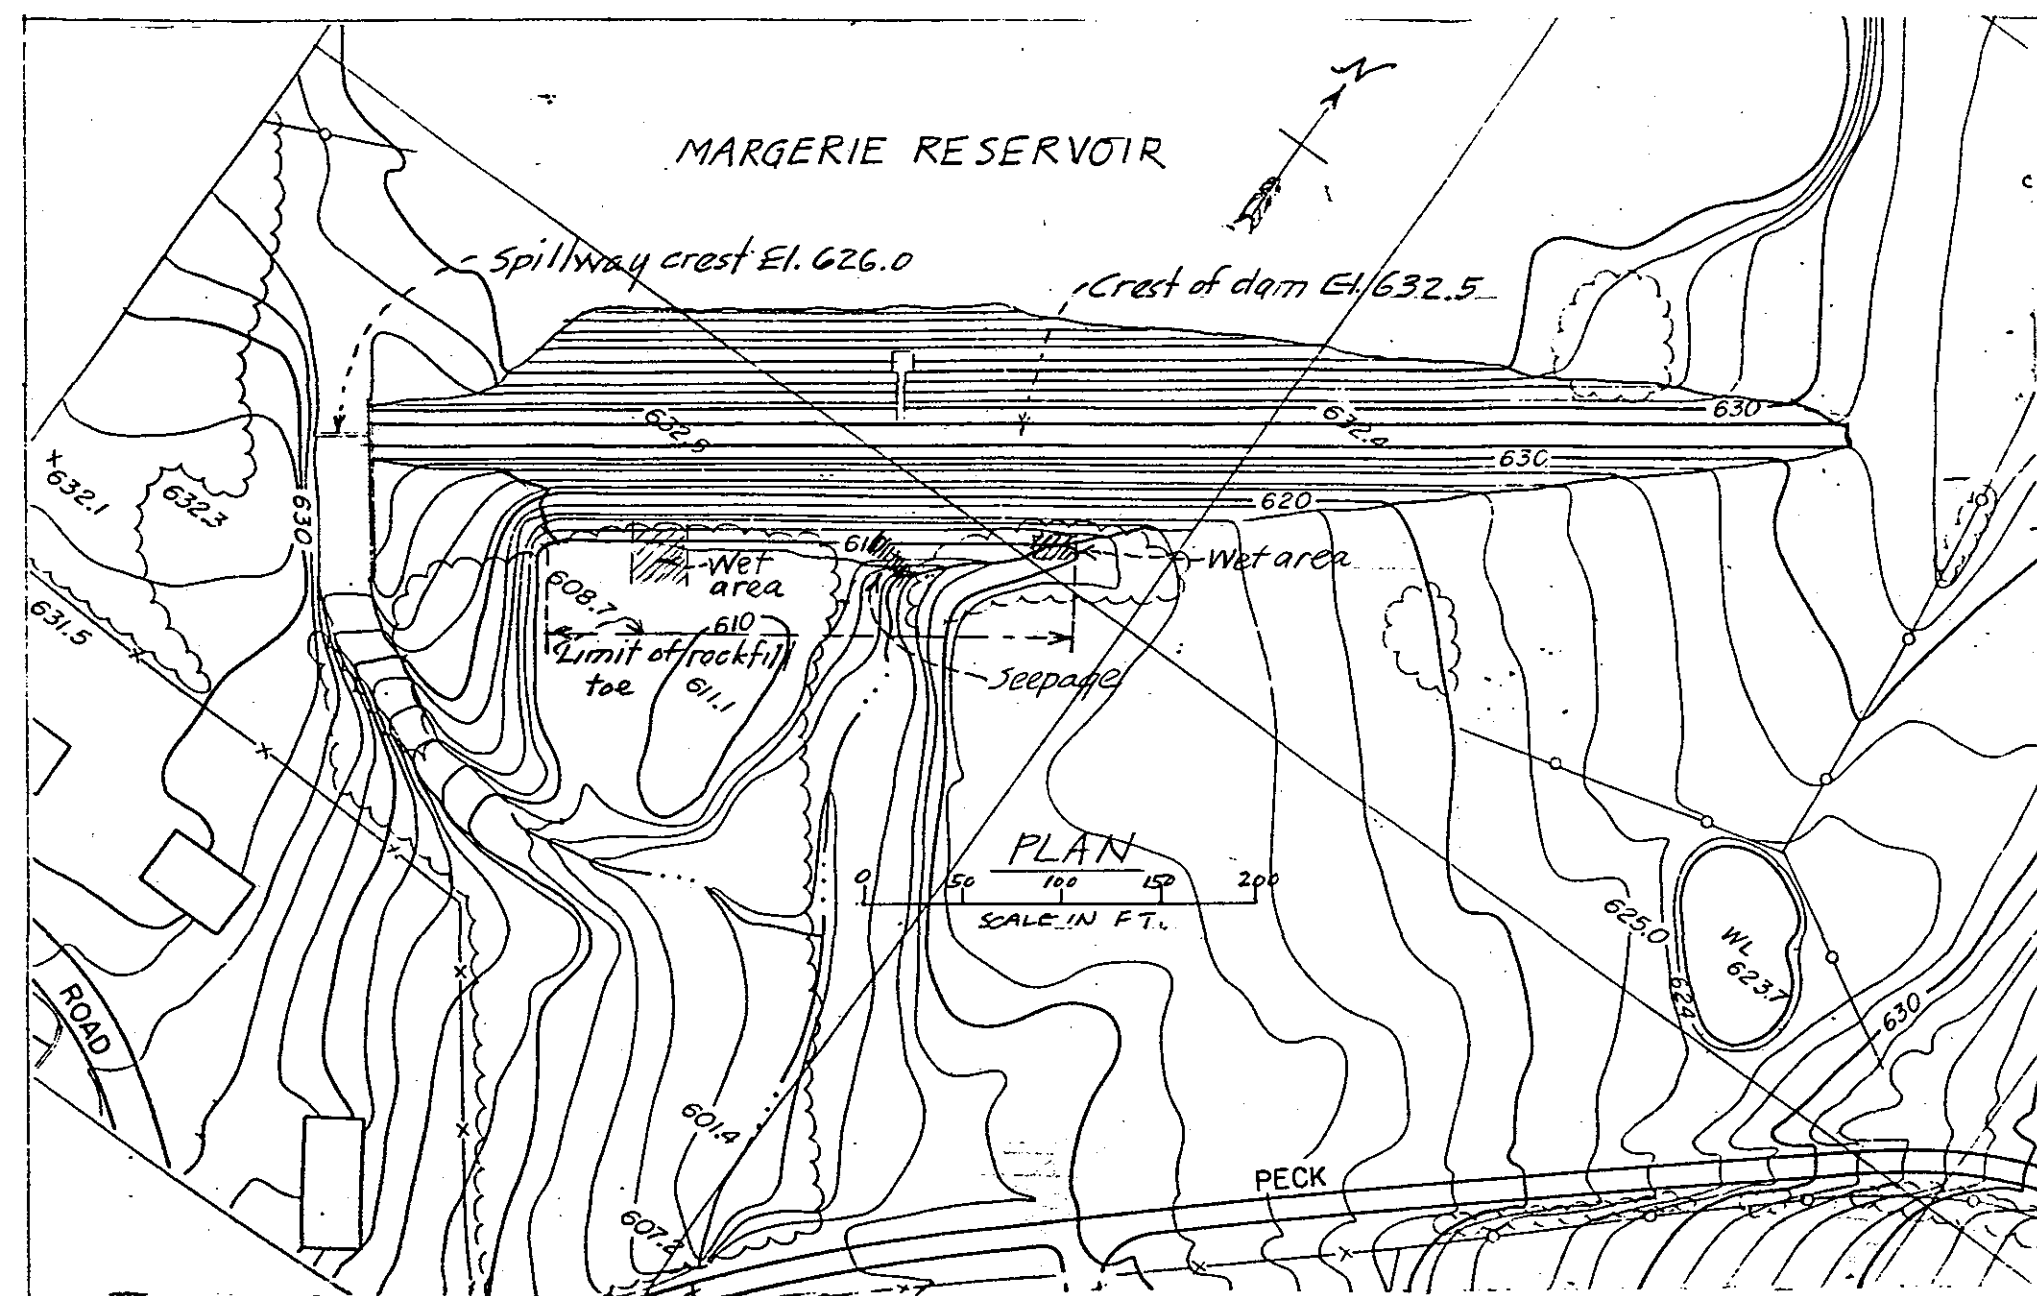
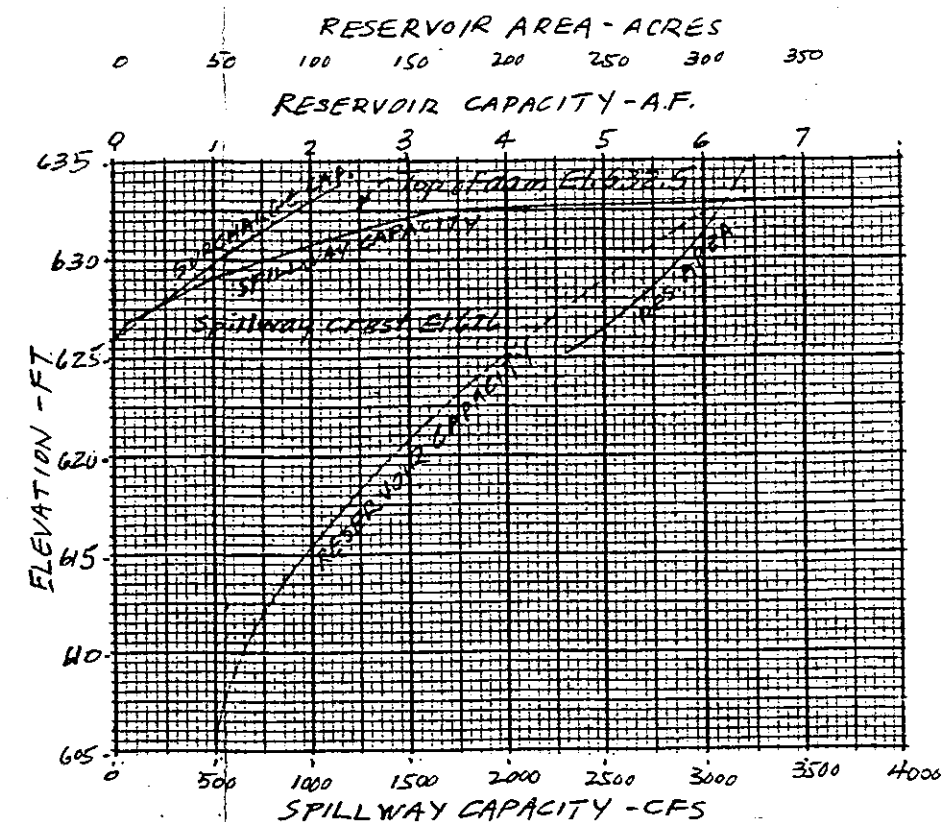
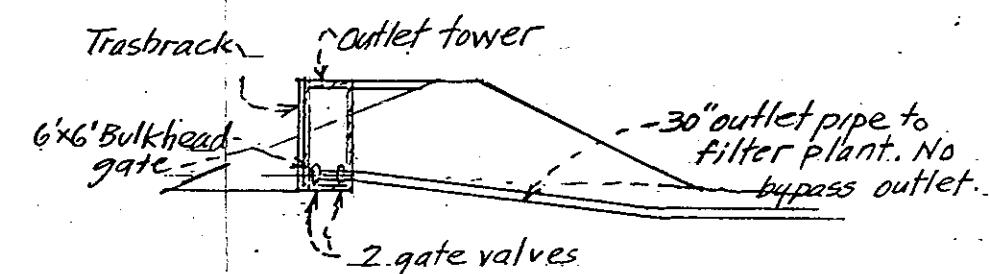
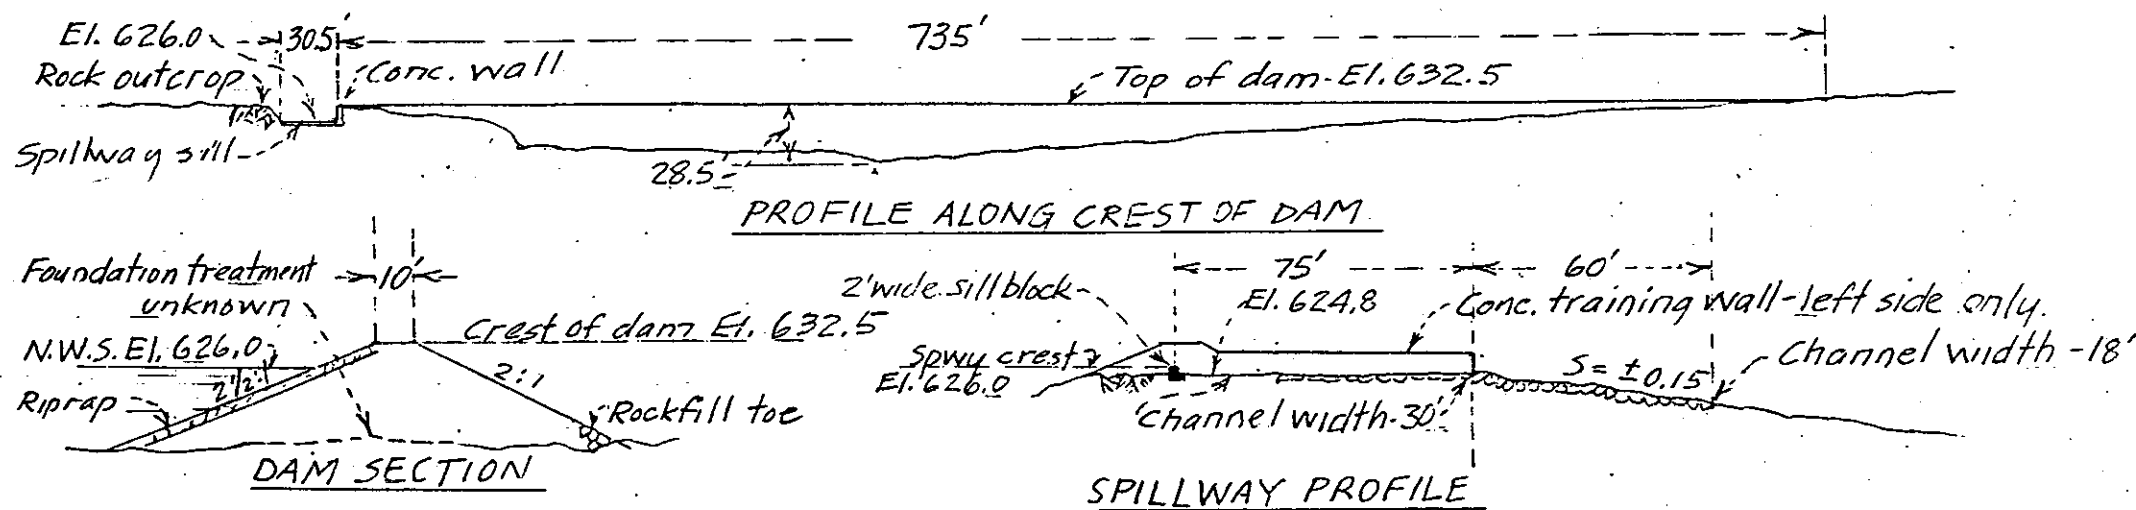
FIGURE 1

Three locations at downstream toe of main dam as noted on Figure 1.

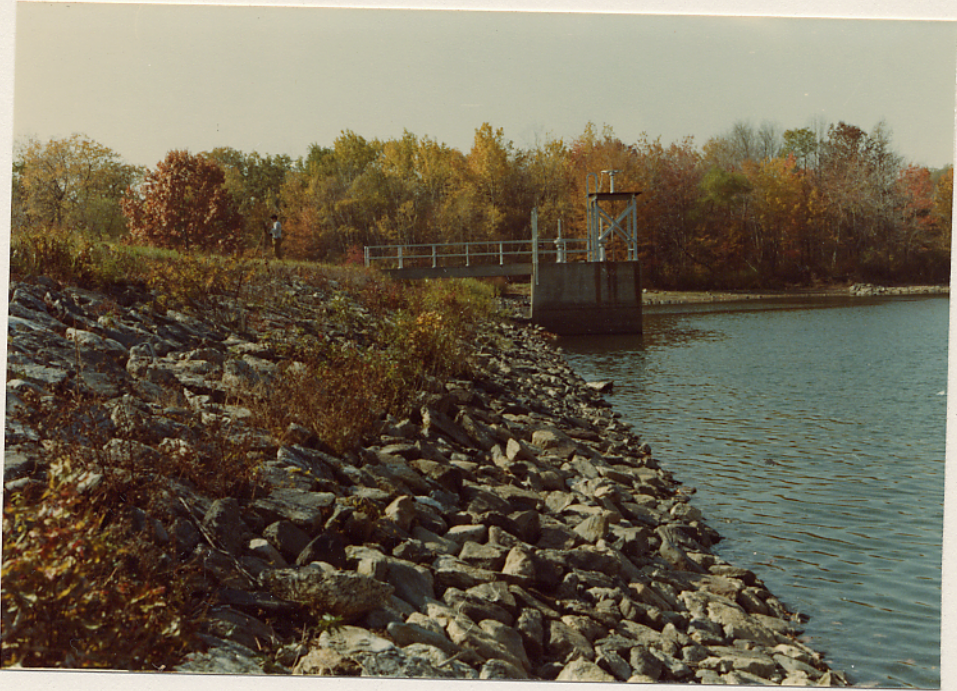
1. Upstream slope and outlet shaft from left abutment of main dam.

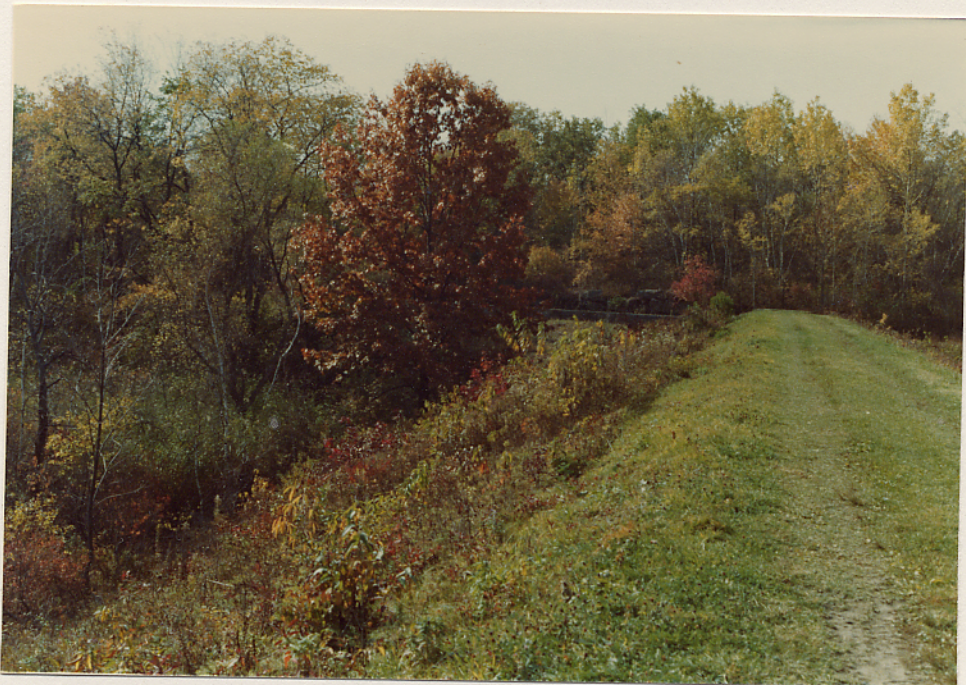
2. Downstream slope from crest of dam near outlet structure.

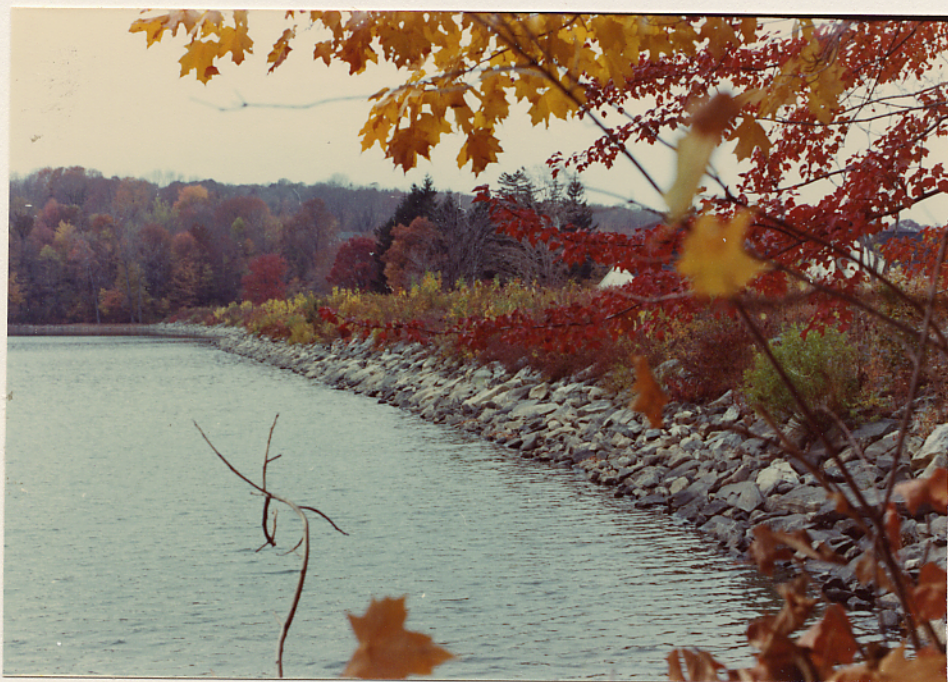
3. Upstream slope of north dike from right abutment.

3. Two small chuckholes in the main dam approximately 40 ft. left of the spillway left training wall should be filled.
4. Riprap missing on the upstream slope of the north dike should be replaced in the area adjacent to the earth ramp near the center of the dike.

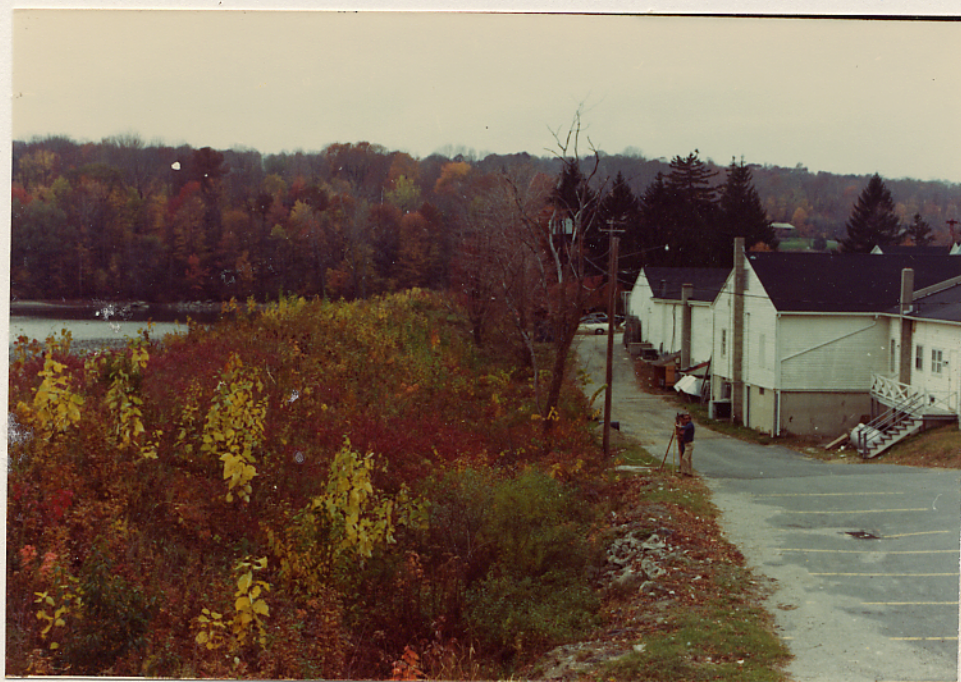
4. Downstream slope of north dike from right abutment.

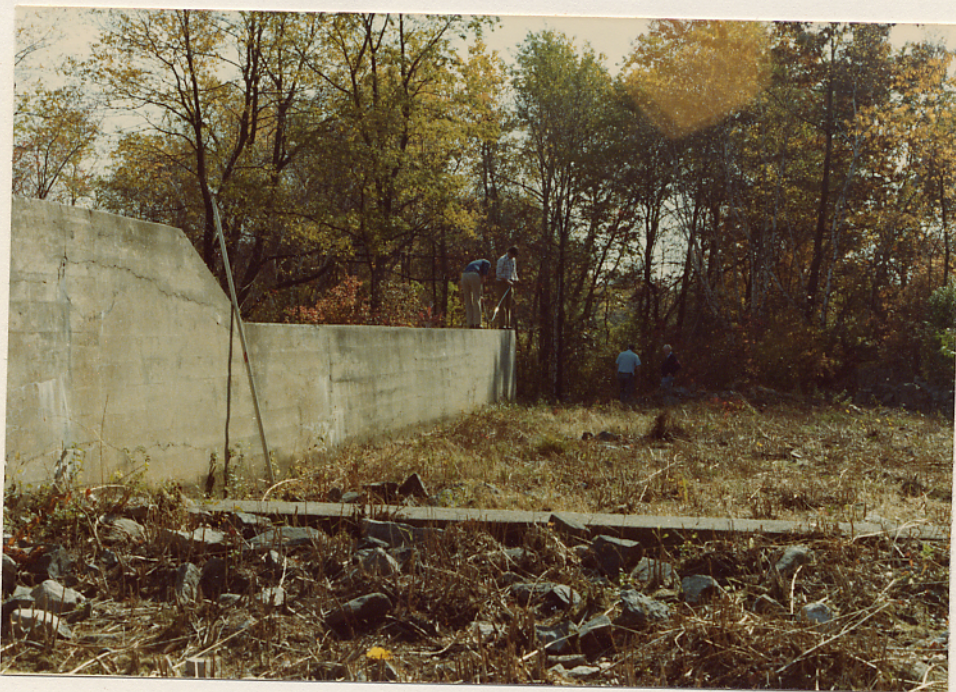
The spillway at the right abutment consists of a 30 ft. wide channel cut through the rock, across which a concrete control sill has been built (Appendix C, Photo No. 5). The unlined channel cut to a depth of 1.2 ft. below spillway level was found to be in generally good condition, with hand-placed rock riprap in the bottom and side slopes. A 75 ft. long concrete retaining and guide wall has been built on the left side of the spillway outlet channel. The concrete appears to be in good condition with some superficial spalling. There is some minor tree and brush growth in the outlet channel about 200 ft. downstream from the spillway, including one tree 12 in. in circumference (Appendix C, Photo No. 6). A wet area was noted at the junction of the spillway outlet channel and natural ground, about 250 ft. downstream from the spillway crest. This wet spot probably results from seepage from the reservoir into the spillway outlet channel.

5. Concrete sill in spillway and left training wall.

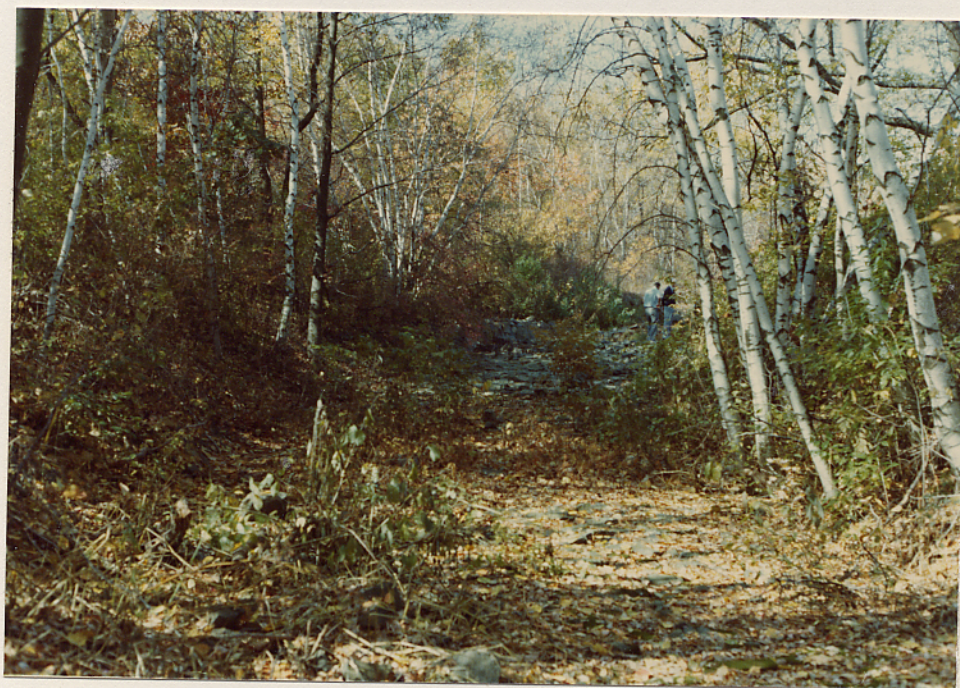
6. Spillway outlet channel looking towards spillway from 250 ft. downstream.
